Contract #: 04-0120F4Cty: SF/ALA Rte: 80 PM: 13.2/13.9File #: 69.28**WELDING INSPECTION REPORT****Resident Engineer:** Pursell, Gary**Address:** 333 Burma Road**City:** Oakland, CA 94607**Report No:** WIR-001861**Date Inspected:** 30-Mar-2008**Project Name:** SAS Superstructure**OSM Arrival Time:** 630**Prime Contractor:** American Bridge/Fluor Enterprises, a JV**OSM Departure Time:** 1730**Contractor:** Zhenhua Port Machinery Company, Ltd (ZPMC), Changxing Island **Location:** Shanghai, China**CWI Name:** Chen Xie**CWI Present:** Yes No**Inspected CWI report:** Yes No N/A**Rod Oven in Use:** Yes No N/A**Electrode to specification:** Yes No N/A**Weld Procedures Followed:** Yes No N/A**Qualified Welders:** Yes No N/A**Verified Joint Fit-up:** Yes No N/A**Approved Drawings:** Yes No N/A**Approved WPS:** Yes No N/A**Delayed / Cancelled:** Yes No N/A**Bridge No:** 34-0006**Component:** Deck panels**Summary of Items Observed:**

OBG bay 1 (Gantry 1)

Gantry 2

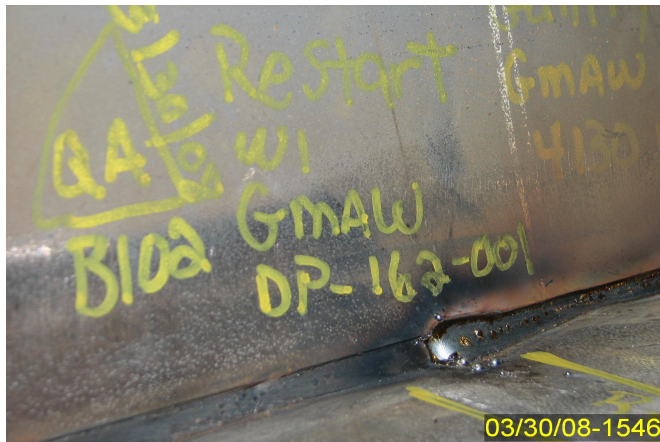
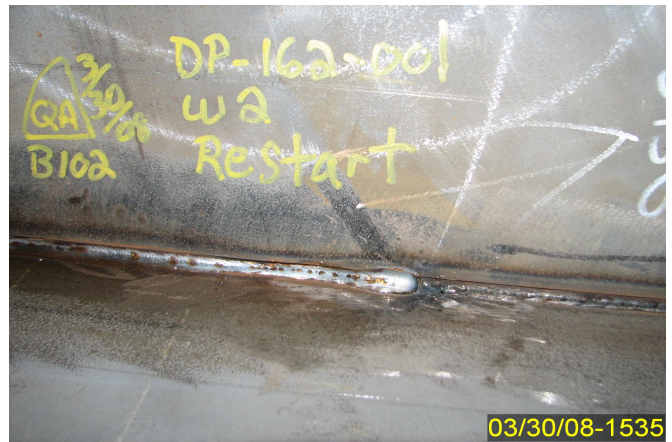
After the completion of the PMT QA observed ZPMC qualified welding personnel perform the GMAW and SAW welds joining the closed U-Ribs to deck panel DP-271-001. QA observed 4 ZPMC QC inspectors in the vicinity of the welding operations including ZPMC CWI identified as Chen Xie. There were also 4 American Bridge/Fluor (ABF) inspectors in the area as well. QA and ABF QC inspectors performed a random visual inspection of the GMAW root welds on this panel. All welds appeared to meet the requirements of the contract documents. QA and QC monitored the welding process continuously throughout the day. QA completed a production panel welding report for the above mentioned panel. The report is on file in the Caltrans QA office. The welding parameters as measured with the calibrated gages on the machines appeared to be in conformance with the posted WPS's.

GMAW

Volts: 30.4 – 30.9 Amps: 359 – 381 Travel Speed: 530 mmpm

SAW

Volts: 24.6 – 26.1 Amps: 676 – 689 Travel Speed: 510 - 515 mmpm
